DEPARTMENT OF TRANSPORTATION**DIVISION OF ENGINEERING SERVICES**

Contract #: 04-0120F4Cty: SF/ALA Rte: 80 PM: 13.2/13.9File #: 1.28**WELDING INSPECTION REPORT****Resident Engineer:** Casey, William**Address:** 333 Burma Road**City:** Oakland, CA 94607**Report No:** WIR-029981**Date Inspected:** 05-Sep-2013**Project Name:** SAS Superstructure**OSM Arrival Time:** 700**Prime Contractor:** American Bridge/Fluor Enterprises, a JV**OSM Departure Time:** 1730**Contractor:** American Bridge/Fluor Enterprises, a JV**Location:** Job Site**CWI Name:** Bernie Docena, Jesse Cayabyab**CWI Present:** Yes No**Inspected CWI report:** Yes No N/A**Rod Oven in Use:** Yes No N/A**Electrode to specification:** Yes No N/A**Weld Procedures Followed:** Yes No N/A**Qualified Welders:** Yes No N/A**Verified Joint Fit-up:** Yes No N/A**Approved Drawings:** Yes No N/A**Approved WPS:** Yes No N/A**Delayed / Cancelled:** Yes No N/A**Bridge No:** 34-0006**Component:** SAS Tower**Summary of Items Observed:**

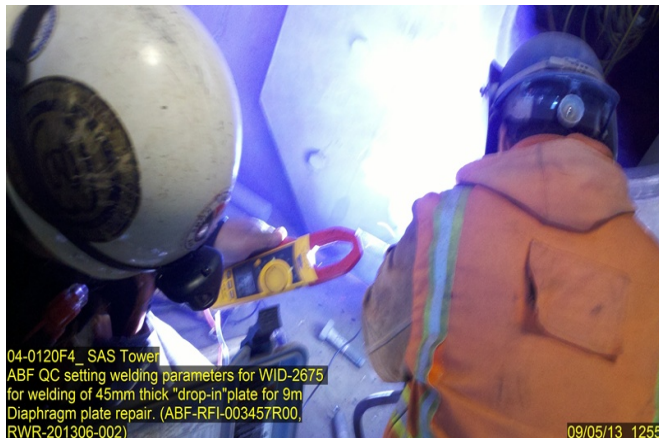
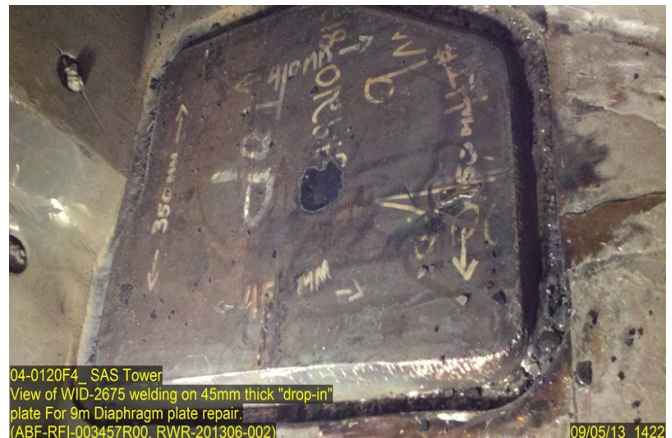
ESW E-043, Location "Q"-Face B:

The QA Inspector observed ABF welding personnel Kit Lai (WID-2953) performing Flux Cored Arc Welding on diaphragm plate at the 9m location adjacent to ESW "Q" Face B. The work is being performed per approved RFI 003457R00 and Request for Weld Repair (RWR) 201306-002. The weld joint detail is TC-P4-GF with a single bevel groove angle of 45° and 37mm PJP to be welded. Prior to welding ABF QC had set welding parameters on the FCAW welding unit. Mr. Lai was observed preheating the weld to over 350° Fahrenheit prior to welding using the Miller ProHeat 35 with heat induction blankets. The welder was using .052 diameter electrode (E71T-1M) per ABF Welding Procedure Specification (WPS) ABF-WPS-D15-3160-Repair Rev.1. The QA Inspector also verified welding parameters with a Fluke 337 current Clampmeter at 238 amps and 24 volts with a preheat of 350° Fahrenheit. After initial root pass had cooled ABF QC Inspector Bernie Docena performed Magnetic Particle Testing of the root pass and did not observe any relevant indications. Mr. Docena also performed welding parameters verifications at random intervals throughout the shift. The welding observed appeared to be in compliance with the WPS noted above.
